# CASE STUDY

## PETRON BATAAN REFINERY FLARE PROJECT

### FLARE STACK REPAIR AND SERVICING

### Petron Refinery Flare - 2 Stack

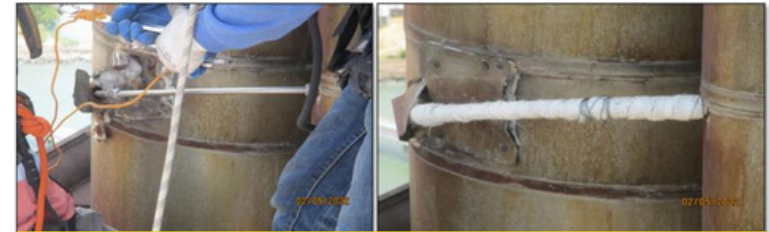
Restore damage insulation and cladding.

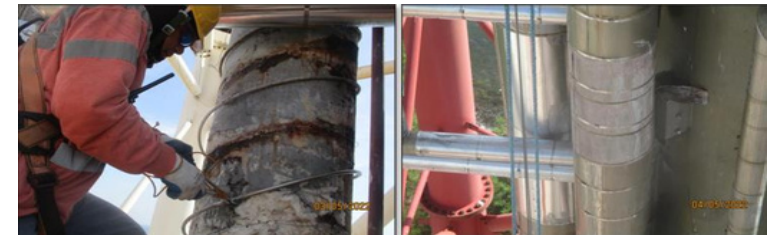
Repairing of leaking tracing line and cladding restoration

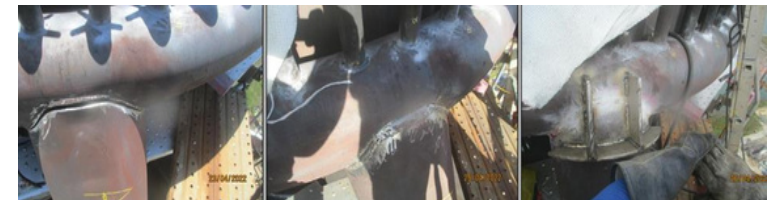
Crack restoration

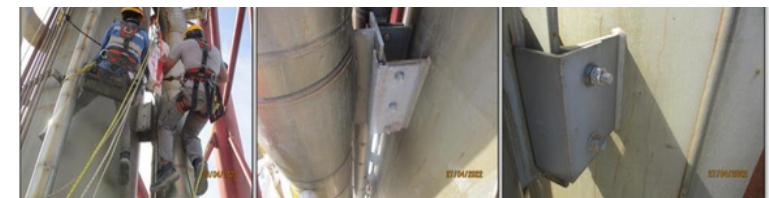
Support restoration and replacing missing bolts.

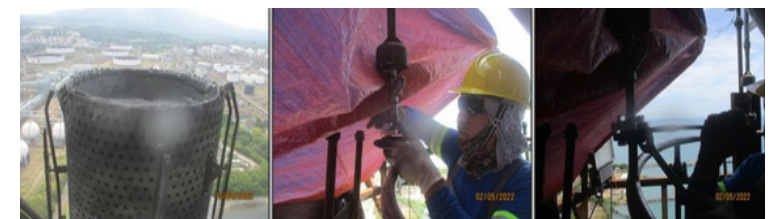
Repair and installation of all eight (8) pilot tips of the acid flare tip.
