# Case Study

## Stack Preventive Maintenance Limay Power Plant, Philippines

Chimney Height	100m
Type of stack	Reinforced Concrete
No. of platforms	5

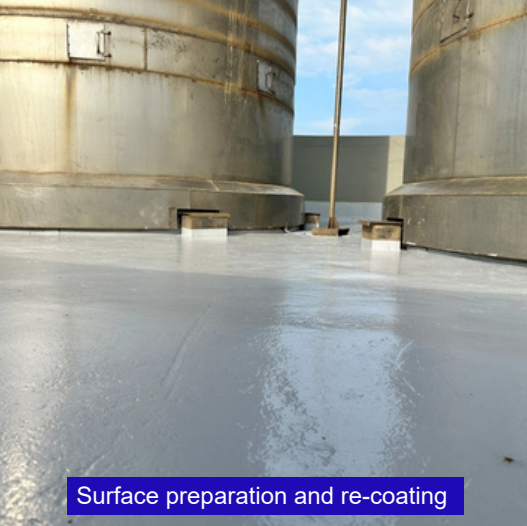
Surface preparation and re-coating

- Surface preparation and re-coating of deteriorated paint areas for corrosion protection
- Concrete restoration on internal and external surfaces, including sealing of hairline cracks
- Repair and replacement of damaged protective insulation on key structural elements
- Cable tray cleaning to enhance safety and orderliness

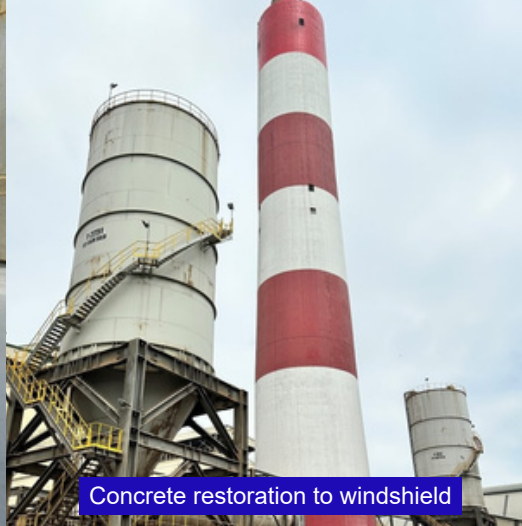
Concrete restoration to windshield

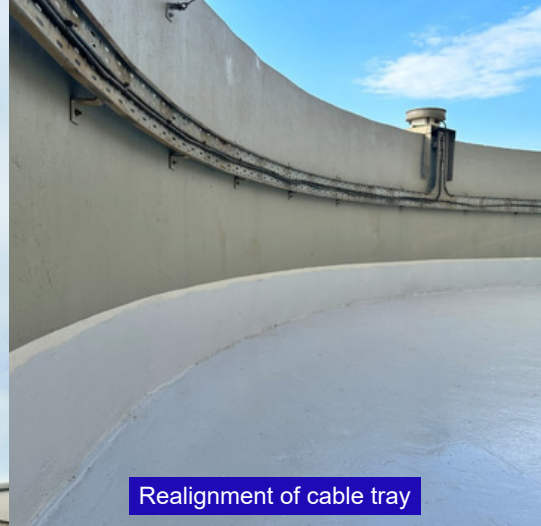
Realignment of cable tray
