Case Study

Emergency Repair of Cladding Kuwait

BEC was called upon to resolve an emergency at the Az-Zour Power Station in Kuwait. High winds had caused the cladding on the Unit 2 flue liner to become dislodged, posing a safety hazard to personnel and risking damage to the equipment below. Access to the site was facilitated using a permanent staircase and gantries within the annular space of the reinforced concrete windshield. This critical task required swift action to ensure the safety of both the plant and the crew.

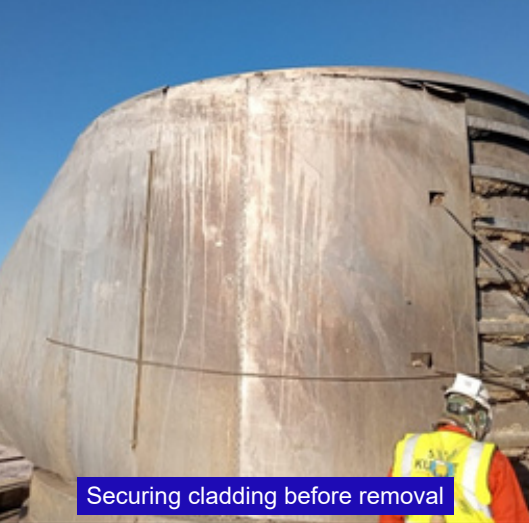
Securing cladding before removal

The cladding was secured using wire slings and chain blocks to prevent it from falling during the operation.

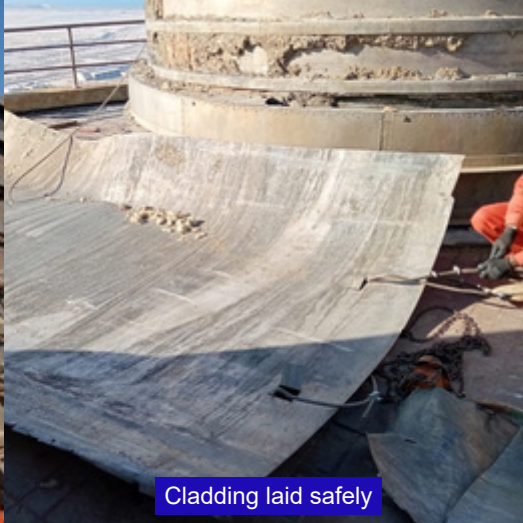
Cladding laid safely

Once secured, BEC carefully moved the cladding within the handrails to a designated safety zone.

The team utilised grinders to cut the cladding into smaller, manageable sections, which were then passed through the access hatch.

The sections were stored safely at the floor level below the roof, with all rigging equipment removed and the area cleared.

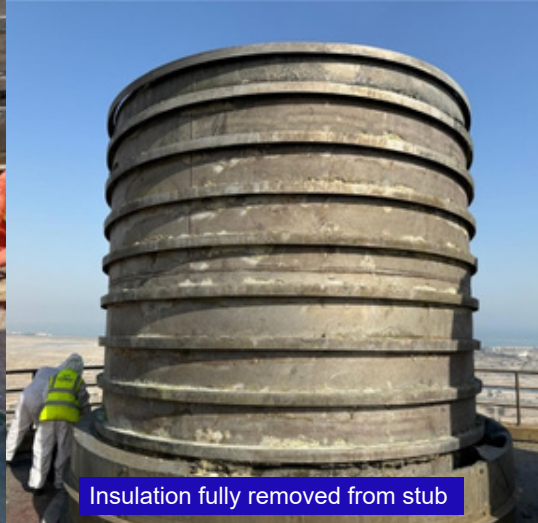
Insulation fully removed from stub
