# CASE STUDY

## PETRON BATAAN REFINERY FLARE PROJECT

### FLARE STACK REPAIR AND SERVICING

### Petron Refinery Flare - 2 Stack

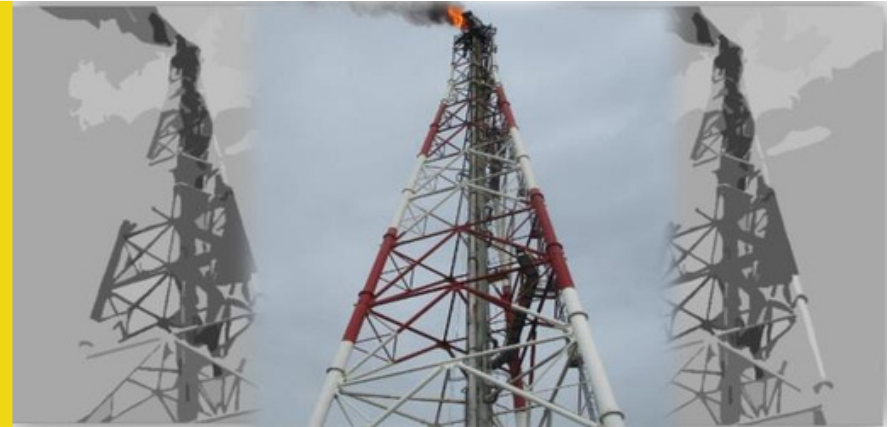
FLARE STACK

PETRON BATAAN REFINERY, INC contracted BEC to carry out the repair work on the Flare Stack, located in Limay, Bataan, Philippines.
